# NATIONAL TRANSPORTATION SAFETY BOARD

## MATERIALS LABORATORY FACTUAL REPORT

Report No. 16-047

Place : McAllen, Texas  
Date : August 17, 2015  
Vehicle : Zenair CH2000  
NTSB No. : CEN15FA362  
Investigator : Josh Lindberg, AS-ERA

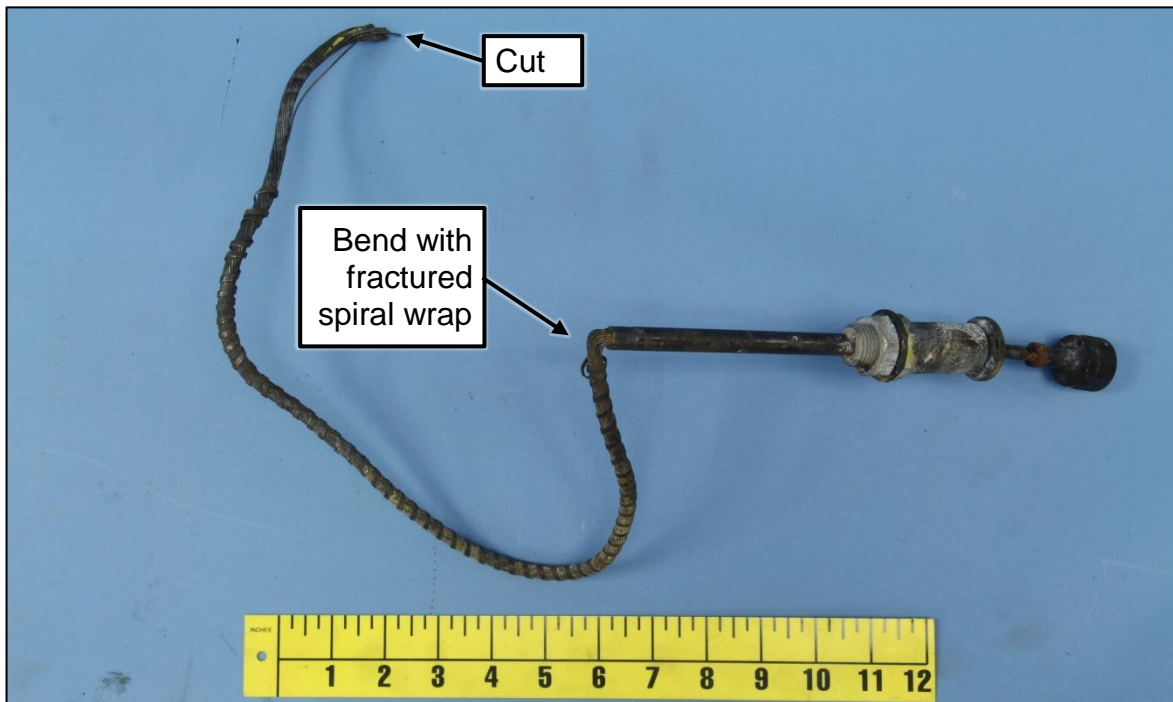
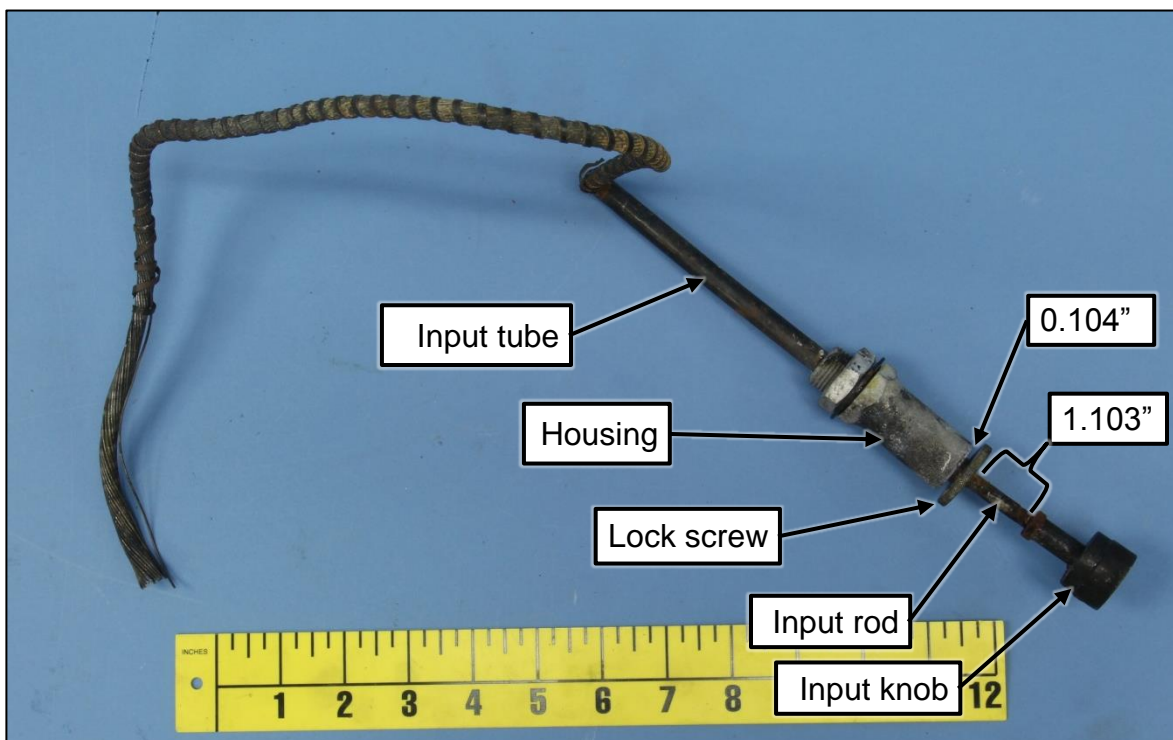
Overall views of the throttle control assembly are shown in figure 1. The control assembly was discolored and oxidized consistent with exposure to a fire. The surface of the aluminum alloy housing also was wrinkled consistent with exposure to high heat. The control cable had been cut at the location indicated in figure 1. The cable was bent approximately 90 degrees at the output end of the input tube, and the spiral wrap around the cable housing wires was fractured and displaced at the location of the bend. The input rod was also bent slightly where it intersected the lock screw opening (see figure 2).

Dimensional measurements were taken of the input control positions using Vernier calipers. The exposed portion of the input rod between the lock screw and the jam nut for the input knob measured 1.103 inches. The gap between the underside (panel side) of the knurled lock screw head and the end of the housing was 0.104 inch. These measurements of the input assembly are indicated in figure 1.

Figure 1. Overall views of the throttle control assembly. The cable was cut at the location indicated.

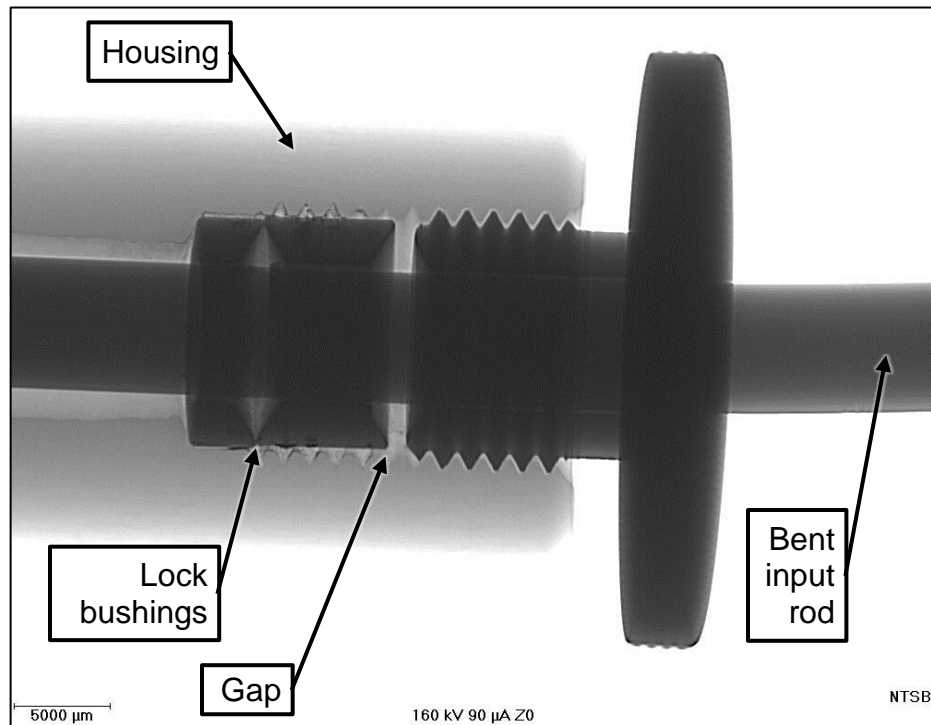
Radiographs of the throttle control input assembly are shown in figures 2 and 3. The lock mechanism, shown in figure 2, had a gap between the lock screw and the lock bushings as indicated, consistent with an unlocked position. The output end of the input assembly is shown in figure 3. The cable was straight in the segment within the input tube between the input rod and the cable housing as shown in figure 3.

within a chuck in the CT stage. CT images of the lock mechanism showed gaps present around much of the circumference of the lock bushings consistent with an unlocked position.

Figure 2. Radiograph of the lock mechanism at the input end of the control housing showing a gap between the lock screw and the lock bushings.

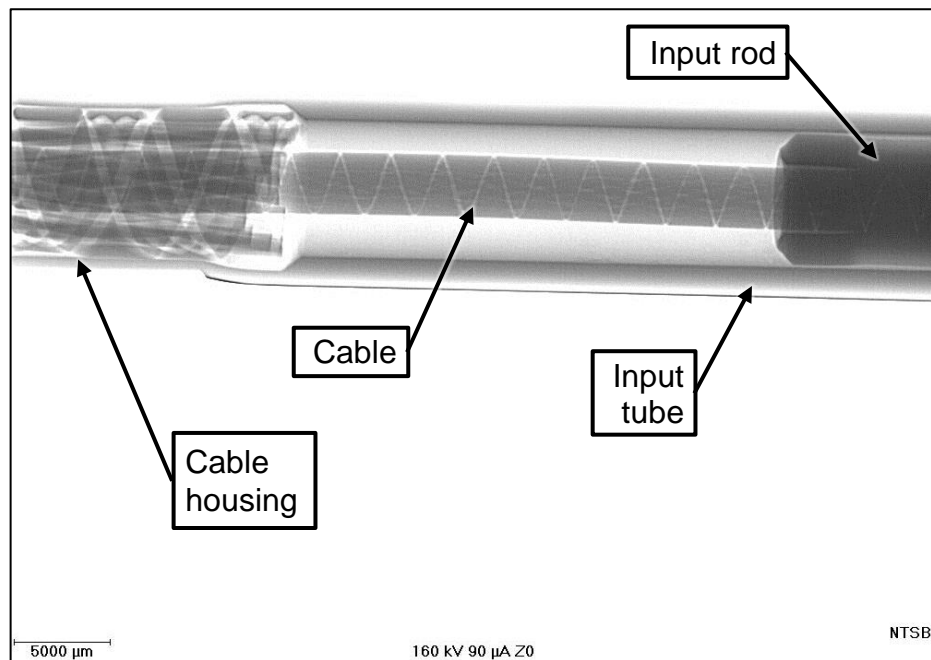
Figure 3. Radiograph of the input assembly at the output end of the input tube.

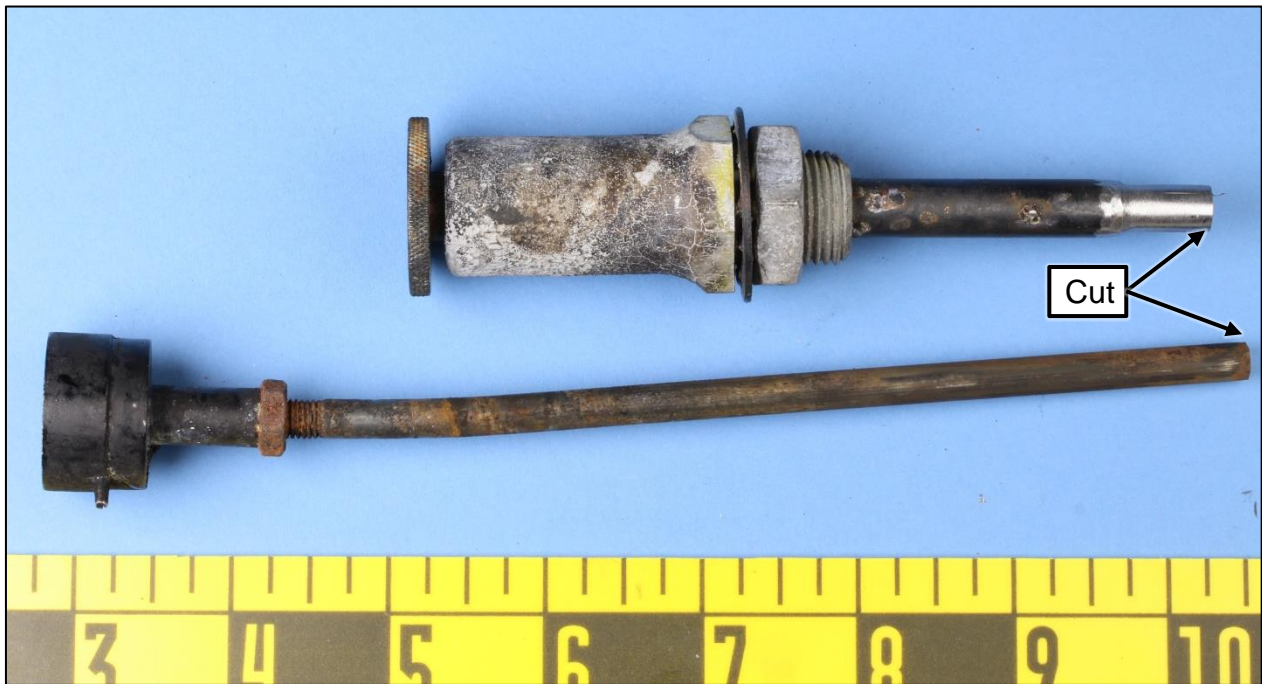
After the CT examination was complete, the input rod was manipulated by hand. Initially, the input knob was pushed inward (toward the panel as installed on the airplane), and the rod moved slightly under hand forces. Next the input knob was pulled in the opposite direction, and the input rod slid completely out of the assembly with minimal hand forces. A view of the input assembly after the rod was removed is shown in figure 4.

Figure 4. Throttle control assembly after cutting and machining to facilitate a CT examination followed by removal of the input rod by hand.
